**Flood Control Project Maintenance
Levee Inspections**

Maintenance Issue Types Only, Levee Inspection Report By Mile - Spring 2019

Sutter Maintenance Yard Wadsworth Canal

Waterway	Bank	Unit Miles	Inspection Start/End	Inspector
Unit No. 01 Wadsworth Canal	Left	4.63	05/08/2019 05/08/2019	Makar Sokol

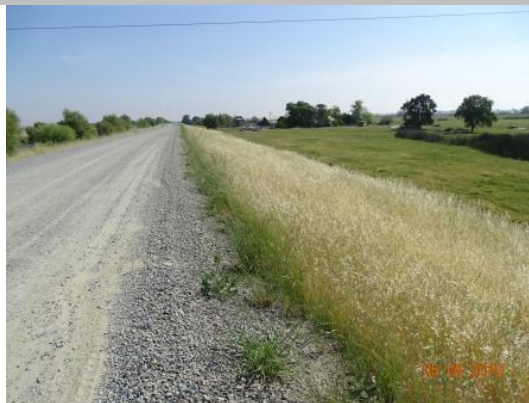
Photo 1 of 1 : SP_2019_ST0010_42_2_20190510_00052.jpg

LM Start	0.03	Rating **	U	Issue No.	2
LM End	4.61	Issue Type +	Ma	Location *	LS
Category	Earthen Levee			GPS Latitude/Longitude	
				Start	End
Item	Vegetation			39.113804 °	39.170986 °
				-121.768283 °	-121.726687 °
DWR ID	DWR_ST0010_01_s_2012_2				
Comment Code					
V1 : Control annual grass and weeds on the levee slopes and easements.					
Inspector Comment

View of the vegetation on the landside slope. Spring 2019.

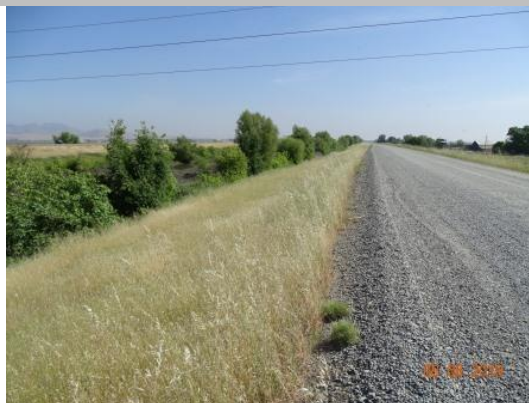
Photo 1 of 1 : SP_2019_ST0010_42_9_20190510_00053.jpg

LM Start	0.03	Rating **	U	Issue No.	9
LM End	4.61	Issue Type +	Ma	Location *	WS
Category	Earthen Levee			GPS Latitude/Longitude	
				Start	End
Item	Vegetation			39.113805 °	39.170986 °
				-121.768283 °	-121.726687 °
DWR ID	DWR_ST0010_01_s_2012_9				
Comment Code					
V1 : Control annual grass and weeds on the levee slopes and easements.					
Inspector Comment

View of the vegetation on the waterside slope. Spring 2019.

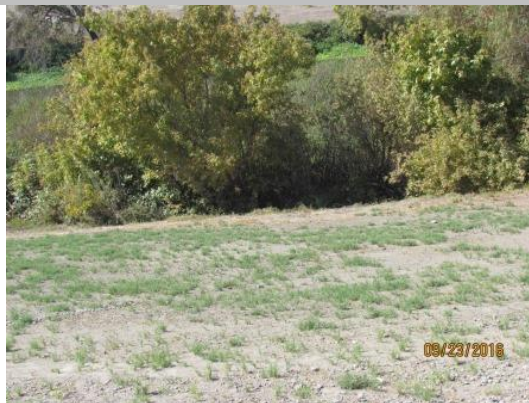
Photo 1 of 1 : SP_2019_ST0010_42_20_20190327_00013.jpg

LM Start	0.06	Rating **	A/W	Issue No.	20
LM End	0.12	Issue Type +	Ma	Location *	WS
Category	Earthen Levee			GPS Latitude/Longitude	
				Start	End
Item	Erosion / Bank Caving			39.114203 °	39.114842 °
				-121.768015 °	-121.767382 °
DWR ID	DWR_ST0010_01_f_2016_20				
Comment Code					
E1 : Note and monitor erosion site.					
Inspector Comment

View of the erosion along the waterside toe.

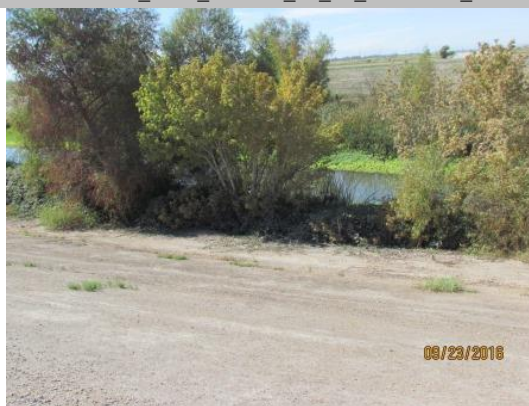
Photo 1 of 1 : SP_2019_ST0010_42_19_20190327_00012.jpg

LM Start	0.38	Rating **	A/W	Issue No.	19
LM End	0.38	Issue Type +	Ma	Location *	WS
Category	Earthen Levee			GPS Latitude/Longitude	
				Start	End
Item	Erosion / Bank Caving			39.117910 °	39.117910 °
				-121.764497 °	-121.764497 °
DWR ID	DWR_ST0010_01_f_2016_19				
Comment Code					
E1 : Note and monitor erosion site.					
Inspector Comment

View of the erosion along the waterside toe.

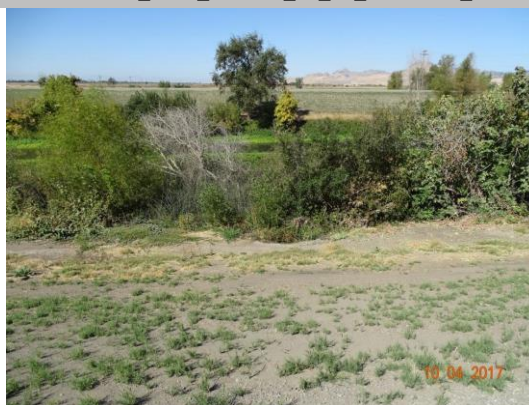
Photo 1 of 1 : SP_2019_ST0010_42_22_20190327_00014.jpg

LM Start	0.50	Rating **	U	Issue No.	22
LM End	0.50	Issue Type +	Ma	Location *	WS
Category	Earthen Levee			GPS Latitude/Longitude	
				Start	End
Item	Erosion / Bank Caving			39.119348 °	39.119348 °
				-121.763120 °	-121.763120 °
DWR ID	DWR_ST0010_01_f_2017_22				
Comment Code					
E2 : Schedule repair of erosion site prior to the next inspection.					
Inspector Comment					
Repair the beaver hole along the waterside berm.

View of the beaver hole along the waterside berm.

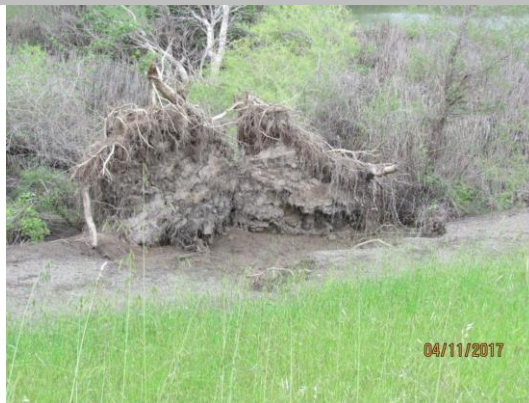
Photo 1 of 1 : SP_2019_ST0010_42_18_20190327_00011.jpg

LM Start	0.56	Rating **	M	Issue No.	18
LM End	0.56	Issue Type +	Ma	Location *	WS
Category	Earthen Levee			GPS Latitude/Longitude	
				Start	End
Item	Erosion / Bank Caving			39.119985 °	39.119985 °
				-121.762600 °	-121.762600 °
DWR ID	DWR_ST0010_01_s_2017_18				
Comment Code					
E2 : Schedule repair of erosion site prior to the next inspection.					
Inspector Comment

View of the erosion along the waterside toe caused by a tree that fell into the water.

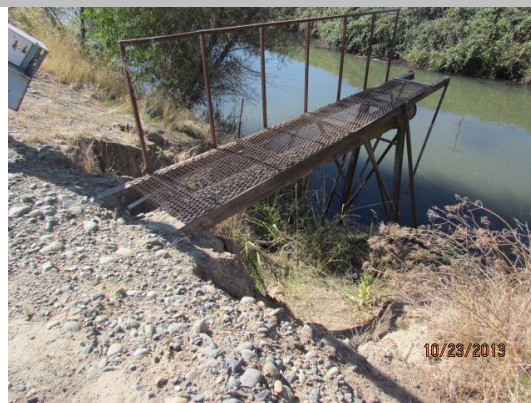
Photo 1 of 3 : SP_2019_ST0010_42_107_20190327_00016.jpg

LM Start	1.85	Rating **	U	Issue No.	107
LM End	1.85	Issue Type +	Ma	Location *	WS
Category	Earthen Levee			GPS Latitude/Longitude	
				Start	End
Item	Erosion / Bank Caving			39.135110 °	39.135110 °
				-121.748230 °	-121.748230 °
DWR ID	DWR_ST0010_01_f_2013_107				
Comment Code					
E2 : Schedule repair of erosion site prior to the next inspection.					
Inspector Comment

View of the erosion along both sides of the abandoned pump.

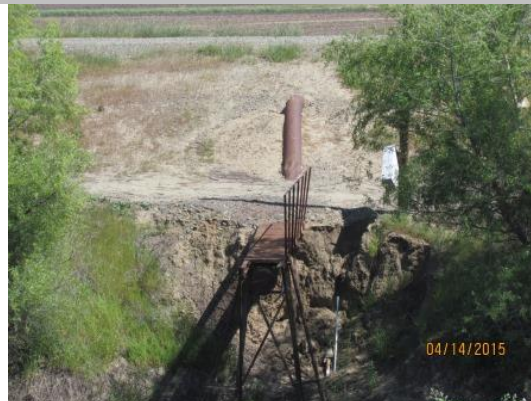
Photo 2 of 3 : SP_2019_ST0010_42_107_20190327_00017.jpg

View of the erosion along both sides of the abandoned pump.

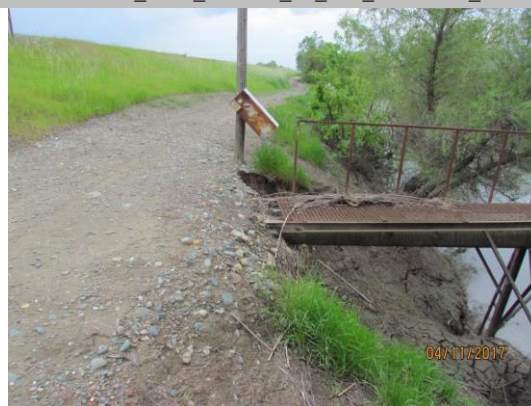
Photo 3 of 3 : SP_2019_ST0010_42_107_20190327_00018.jpg

LM Start	1.85	Rating **	U	Issue No.	107 (cont)	
LM End	1.85	Issue Type +	Ma	Location *	WS	
Category	Earthen Levee			GPS Latitude/Longitude		
				Start		End
Item	Erosion / Bank Caving			39.135110 °		39.135110 °
				-121.748230 °		-121.748230 °
DWR ID	DWR_ST0010_01_f_2013_107					
Comment Code						
E2 : Schedule repair of erosion site prior to the next inspection.						
Inspector Comment

View of erosion along both sides of the abandoned pipe.

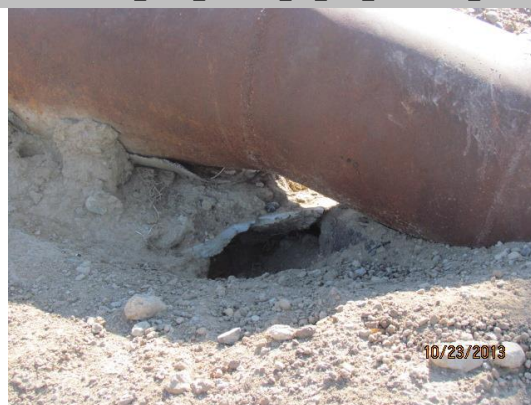
Photo 1 of 1 : SP_2019_ST0010_42_106_20190327_00015.jpg

LM Start	1.85	Rating **	M	Issue No.	106
LM End	1.85	Issue Type +	Ma	Location *	WS
Category	Earthen Levee			GPS Latitude/Longitude	
				Start	End
Item	Animal Control			39.135110 °	39.135110 °
				-121.748229 °	-121.748229 °
DWR ID	DWR_ST0010_01_f_2013_106				
Comment Code					
A3 : No rodents visible, but rodent burrows visible; need to backfill and compact or grout burrows.					
Inspector Comment

View of the rodent holes under the irrigation pipe.

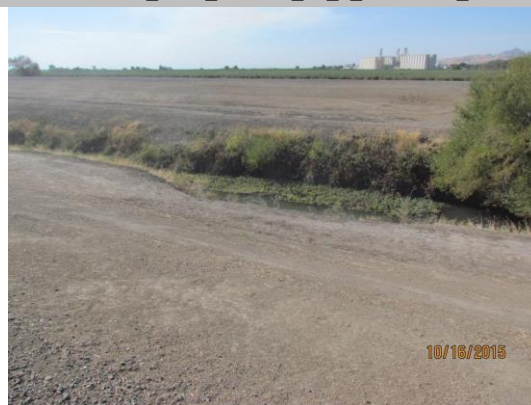
Photo 1 of 4 : SP_2019_ST0010_42_6_20190327_00006.jpg

LM Start	2.43	Rating **	M	Issue No.	6
LM End	3.30	Issue Type +	Ma	Location *	WS
Category	Supplemental			GPS Latitude/Longitude	
				Start	End
Item	2017 USACE Erosion Survey, DRAFT			39.142235 °	39.153095 °
				-121.742609 °	-121.734390 °
DWR ID	DWR_ST0010_01_f_2018_6				
Comment Code					
Inspector Comment					
2017 Site ID: WAC 2.4 L					
Status: Eroding					
2017 Field Notes: Significant new erosion along lower bank.					
Site History: 2010 - Over steepened levees, some slumping, reach-wide problem. 2011 - Still a reach-wide problem.

View of the erosion along the waterside toe.

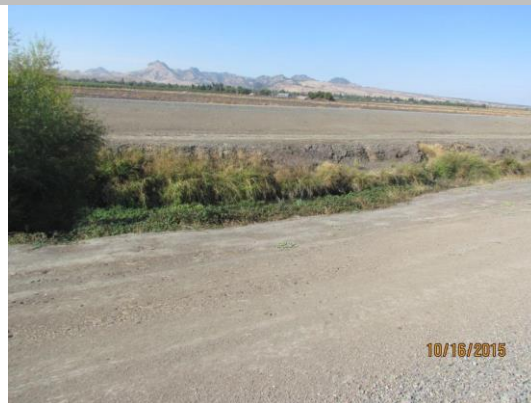
Photo 2 of 4 : SP_2019_ST0010_42_6_20190327_00007.jpg

LM Start	2.43	Rating **	M	Issue No.	6 (cont)
LM End	3.30	Issue Type +	Ma	Location *	WS
Category	Supplemental			GPS Latitude/Longitude	
				Start	End
Item	2017 USACE Erosion Survey, DRAFT			39.142235 °	39.153095 °
				-121.742609 °	-121.734390 °
DWR ID	DWR_ST0010_01_f_2018_6				
Comment Code					
Inspector Comment					
2017 Site ID: WAC 2.4 L					
Status: Eroding					
2017 Field Notes: Significant new erosion along lower bank.					
Site History: 2010 - Over steepened levees, some slumping, reach-wide problem. 2011 - Still a reach-wide problem.

View of the erosion along the waterside toe.

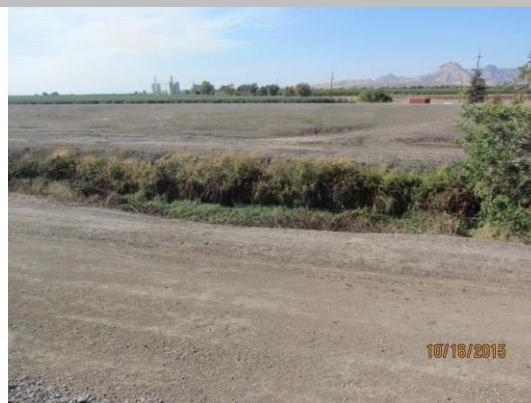
Photo 3 of 4 : SP_2019_ST0010_42_6_20190327_00008.jpg

View of the erosion along the waterside toe.

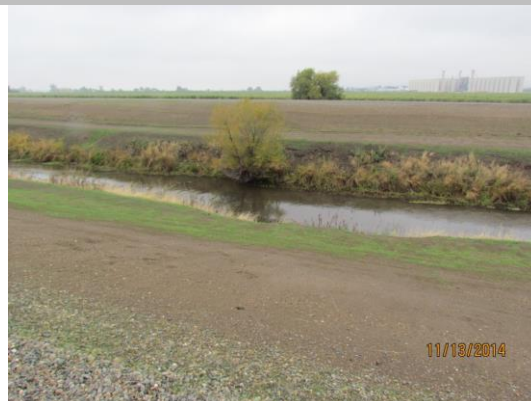
Photo 4 of 4 : SP_2019_ST0010_42_6_20190327_00009.jpg

View of the erosion along the waterside toe.

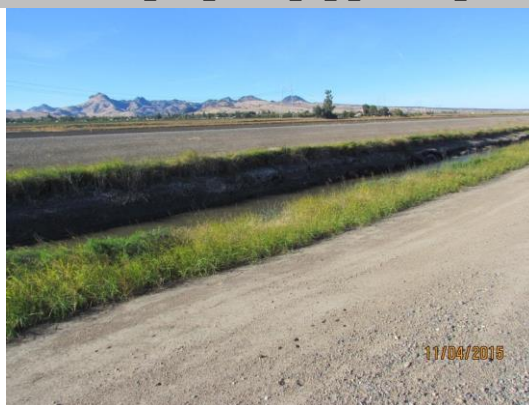
Photo 1 of 1 : SP_2019_ST0010_42_3_20190327_00001.jpg

LM Start	3.53	Rating **	A/W	Issue No.	3
LM End	3.56	Issue Type +	Ma	Location *	WS
Category	Earthen Levee			GPS Latitude/Longitude	
				Start	End
Item	Erosion / Bank Caving			39.156225 °	39.156639 °
				-121.732930 °	-121.732755 °
DWR ID	DWR_ST0010_01_s_2012_3				
Comment Code					
E1 : Note and monitor erosion site.					
Inspector Comment

View of the erosion along the waterside toe.

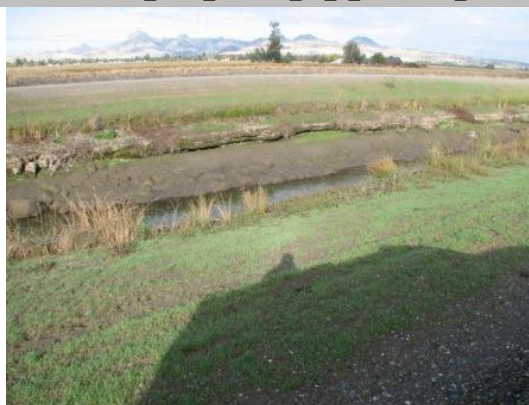
Photo 1 of 2 : SP_2019_ST0010_42_4_20190327_00002.jpg

LM Start	3.65	Rating **	A/W	Issue No.	4
LM End	3.65	Issue Type +	Ma	Location *	WS
Category	Earthen Levee			GPS Latitude/Longitude	
				Start	End
Item	Erosion / Bank Caving			39.157861 °	39.157861 °
				-121.732238 °	-121.732238 °
DWR ID	DWR_ST0010_01_s_2012_4				
Comment Code					
E1 : Note and monitor erosion site.					
Inspector Comment

View of the erosion along the waterside toe of the levee.

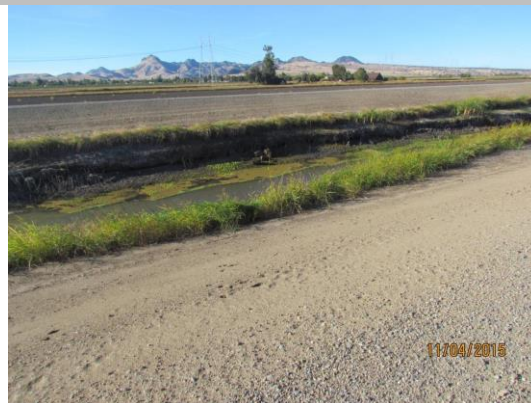
Photo 2 of 2 : SP_2019_ST0010_42_4_20190327_00003.jpg

LM Start	3.65	Rating **	A/W	Issue No.	4 (cont)	
LM End	3.65	Issue Type +	Ma	Location *	WS	
Category	Earthen Levee			GPS Latitude/Longitude		
				Start		End
Item	Erosion / Bank Caving			39.157861 °		39.157861 °
				-121.732238 °		-121.732238 °
DWR ID	DWR_ST0010_01_s_2012_4					
Comment Code						
E1 : Note and monitor erosion site.						
Inspector Comment

View of the erosion along the waterside toe.

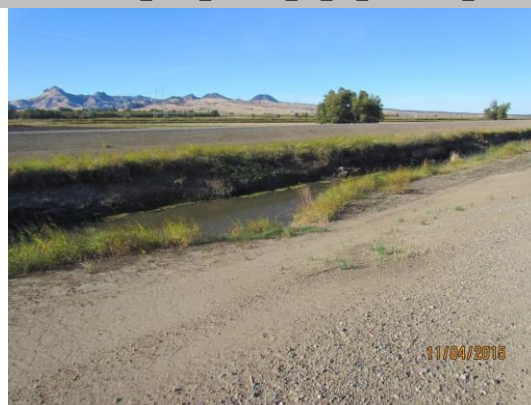
Photo 1 of 1 : SP_2019_ST0010_42_17_20190327_00010.jpg

LM Start	3.84	Rating **	A/W	Issue No.	17
LM End	3.96	Issue Type +	Ma	Location *	WS
Category	Earthen Levee			GPS Latitude/Longitude	
				Start	End
Item	Erosion / Bank Caving			39.160442 °	39.162235 °
				-121.731067 °	-121.730912 °
DWR ID	DWR_ST0010_01_f_2014_17				
Comment Code					
E1 : Note and monitor erosion site.					
Inspector Comment

View of the erosion along the waterside toe.

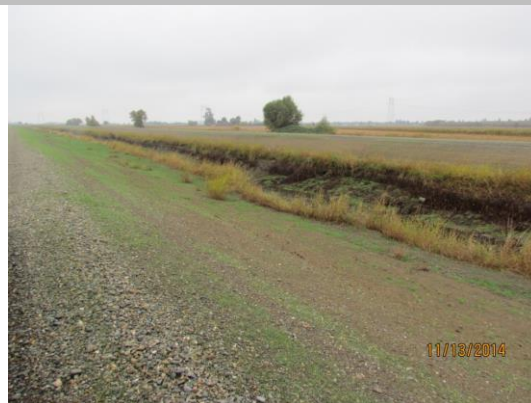
Photo 1 of 2 : SP_2019_ST0010_42_5_20190327_00004.jpg

LM Start	4.23	Rating **	A/W	Issue No.	5
LM End	4.23	Issue Type +	Ma	Location *	WS
Category	Earthen Levee			GPS Latitude/Longitude	
				Start	End
Item	Erosion / Bank Caving			39.165845 °	39.165845 °
				-121.728877 °	-121.728877 °
DWR ID	DWR_ST0010_01_s_2012_5				
Comment Code					
E1 : Note and monitor erosion site.					
Inspector Comment

View of the erosion along the waterside toe.

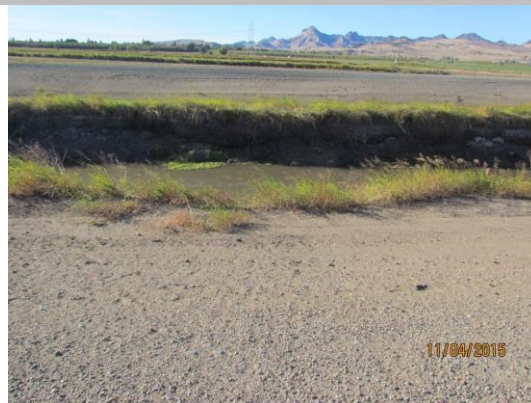
Photo 2 of 2 : SP_2019_ST0010_42_5_20190327_00005.jpg

LM Start	4.23	Rating **	A/W	Issue No.	5 (cont)	
LM End	4.23	Issue Type +	Ma	Location *	WS	
Category	Earthen Levee			GPS Latitude/Longitude		
				Start		End
Item	Erosion / Bank Caving			39.165845 °	39.165845 °	
				-121.728877 °	-121.728877 °	
DWR ID	DWR_ST0010_01_s_2012_5					
Comment Code						
E1 : Note and monitor erosion site.						
Inspector Comment

View of the erosion along the waterside toe.

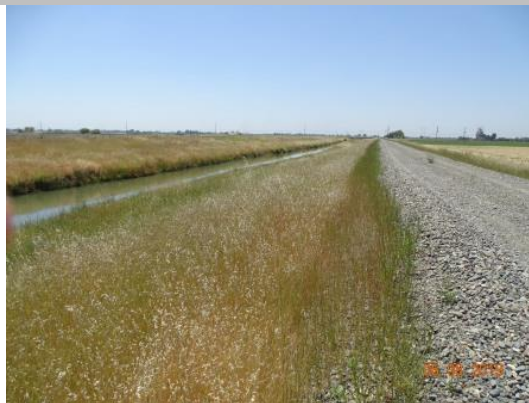
Photo 1 of 1 : SP_2019_ST0010_43_2_20190510_00053.jpg

LM Start	0.02	Rating **	U	Issue No.	2
LM End	4.57	Issue Type +	Ma	Location *	WS
Category	Earthen Levee			GPS Latitude/Longitude	
				Start	End
Item	Vegetation			39.114416 °	39.170959 °
				-121.769271 °	-121.727250 °
DWR ID	DWR_ST0010_02_s_2012_2				
Comment Code					
V1 : Control annual grass and weeds on the levee slopes and easements.					
Inspector Comment

View of the vegetation on the waterside slope. Spring 2019.

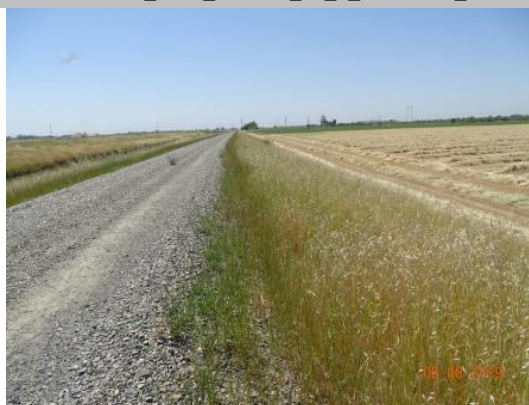
Photo 1 of 1 : SP_2019_ST0010_43_1_20190510_00054.jpg

LM Start	0.02	Rating **	U	Issue No.	1
LM End	4.57	Issue Type +	Ma	Location *	LS
Category	Earthen Levee			GPS Latitude/Longitude	
				Start	End
Item	Vegetation			39.114417 °	39.170959 °
				-121.769270 °	-121.727250 °
DWR ID	DWR_ST0010_02_f_2012_1				
Comment Code					
V1 : Control annual grass and weeds on the levee slopes and easements.					
Inspector Comment

View of the vegetation on the landside slope. Spring 2019.

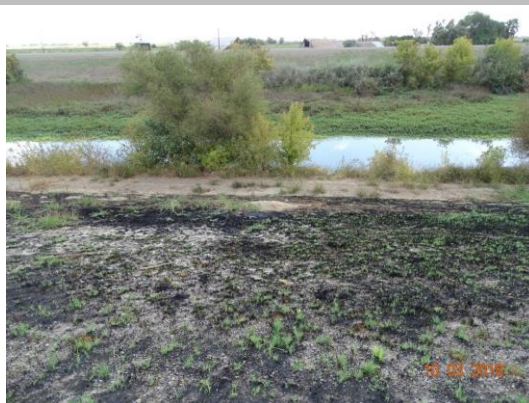
Photo 1 of 1 : SP_2019_ST0010_43_17_20190327_00007.jpg

LM Start	0.24	Rating **	M	Issue No.	17
LM End	0.24	Issue Type +	Ma	Location *	WS
Category	Earthen Levee			GPS Latitude/Longitude	
				Start	End
Item	Animal Control			39.116913 °	39.116913 °
				-121.766768 °	-121.766768 °
DWR ID	DWR_ST0010_02_f_2018_17				
Comment Code					
A3 : No rodents visible, but rodent burrows visible; need to backfill and compact or grout burrows.					
Inspector Comment

View of the rodent hole along the waterside slope.

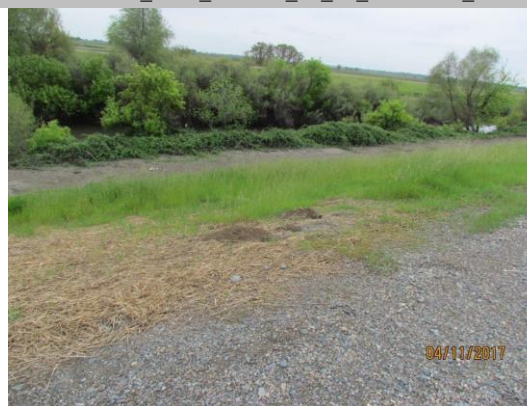
Photo 1 of 1 : SP_2019_ST0010_43_19_20190327_00008.jpg

LM Start	1.16	Rating **	U	Issue No.	19
LM End	1.16	Issue Type +	Ma	Location *	WS
Category	Earthen Levee			GPS Latitude/Longitude	
				Start	End
Item	Animal Control			39.127527 °	39.127527 °
				-121.756493 °	-121.756493 °
DWR ID	DWR_ST0010_02_f_2016_19				
Comment Code					
A3 : No rodents visible, but rodent burrows visible; need to backfill and compact or grout burrows.					
Inspector Comment

View of the rodent holes along the waterside slope.

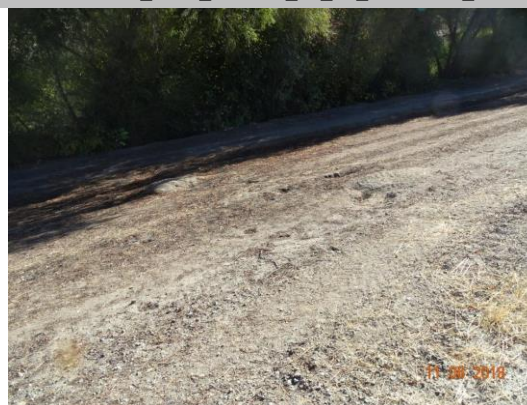
Photo 1 of 1 : SP_2019_ST0010_43_23_20190327_00013.jpg

LM Start	1.71	Rating **	M	Issue No.	23
LM End	1.71	Issue Type +	Ma	Location *	WS
Category	Earthen Levee			GPS Latitude/Longitude	
				Start	End
Item	Animal Control			39.133912 °	39.133912 °
				-121.750258 °	-121.750258 °
DWR ID	DWR_ST0010_02_f_2018_23				
Comment Code					
A3 : No rodents visible, but rodent burrows visible; need to backfill and compact or grout burrows.					
Inspector Comment

View of the rodent holes along the waterside slope.

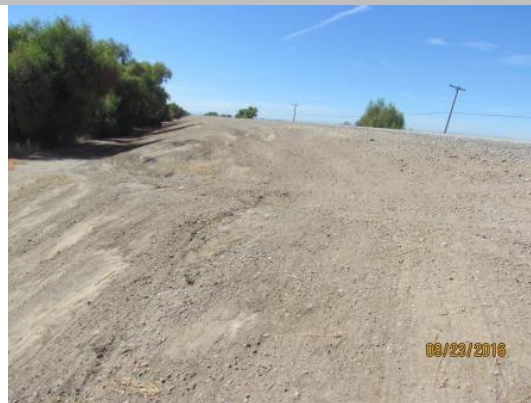
Photo 1 of 1 : SP_2019_ST0010_43_20_20190327_00009.jpg

LM Start	1.75	Rating **	M	Issue No.	20
LM End	1.75	Issue Type +	Ma	Location *	WS
Category	Earthen Levee			GPS Latitude/Longitude	
				Start	End
Item	Slope Stability			39.134378 °	39.134378 °
				-121.749803 °	-121.749803 °
DWR ID	DWR_ST0010_02_f_2016_20				
Comment Code					
S3 : Repair the levee slope damaged by vehicle traffic and prevent access where possible.					
Inspector Comment					
Ramp is causing depression in the levee slope.

View of the ramp encroaching into the levee.

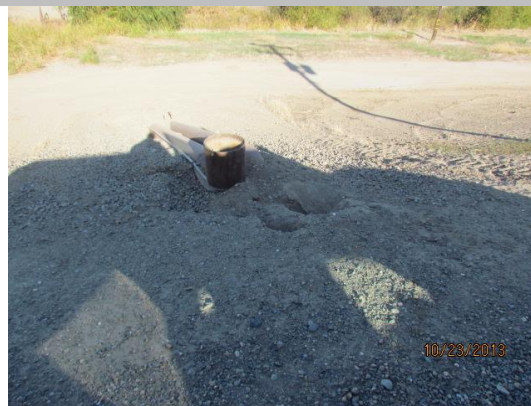
Photo 1 of 2 : SP_2019_ST0010_43_11_20190327_00005.jpg

LM Start	1.76	Rating **	M	Issue No.	11
LM End	1.76	Issue Type +	Ma	Location *	LS
Category	Earthen Levee			GPS Latitude/Longitude	
				Start	End
Item	Animal Control			39.134490 °	39.134490 °
				-121.749716 °	-121.749716 °
DWR ID	DWR_ST0010_02_f_2012_11				
Comment Code					
A3 : No rodents visible, but rodent burrows visible; need to backfill and compact or grout burrows.					
Inspector Comment

View of the rodent holes above the irrigation pipe.

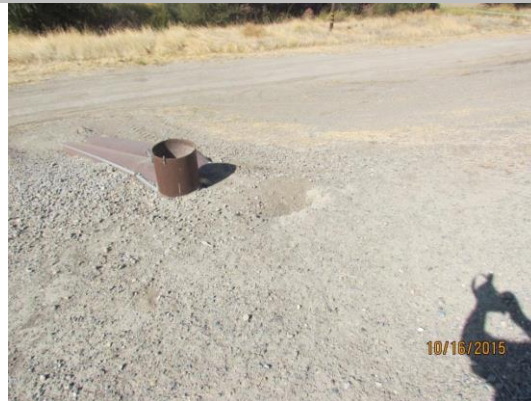
Photo 2 of 2 : SP_2019_ST0010_43_11_20190327_00006.jpg

View of the rodent hole above the irrigation pipe.

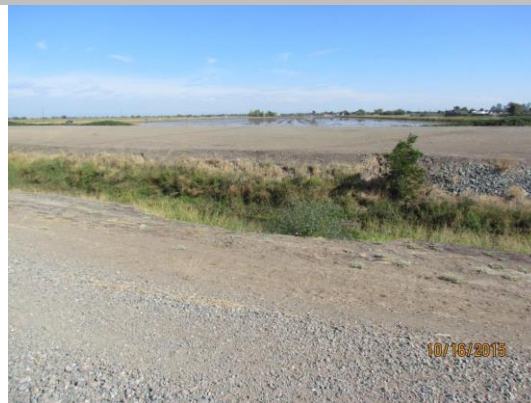
Photo 1 of 2 : SP_2019_ST0010_43_8_20190327_00001.jpg

LM Start	2.41	Rating **	A/W	Issue No.	8
LM End	3.28	Issue Type +	Ma	Location *	WS
Category	Supplemental			GPS Latitude/Longitude	
				Start	End
Item	2017 USACE Erosion Survey, DRAFT			39.142254 °	39.153150 °
				-121.742847 °	-121.734611 °
DWR ID	DWR_ST0010_02_f_2018_8				
Comment Code					
Inspector Comment					
2017 Site ID: WAC 2.4 R					
Status: Eroding					
2017 Field Notes: Significant new erosion along lower bank.					
Site History: 2010 - Over steepened levees, some slumping, reach-wide problem. 2011 - Still a reach-wide problem.

View of erosion along the waterside toe.

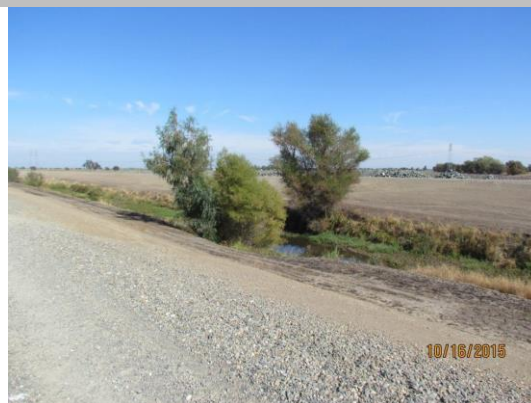
Photo 2 of 2 : SP_2019_ST0010_43_8_20190327_00002.jpg

View of the erosion along the landside toe.

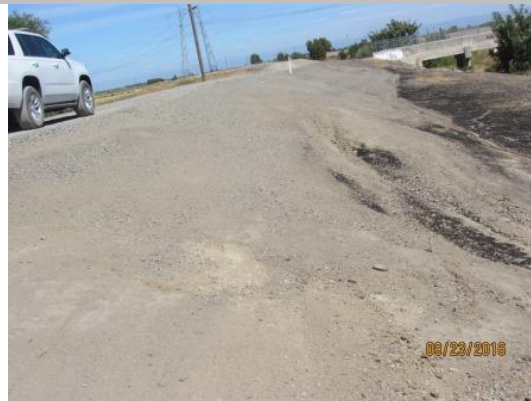
Photo 1 of 1 : SP_2019_ST0010_43_21_20190327_00010.jpg

LM Start	2.95	Rating **	M	Issue No.	21
LM End	2.95	Issue Type +	Ma	Location *	WS
Category	Earthen Levee			GPS Latitude/Longitude	
				Start	End
Item	Slope Stability			39.148938 °	39.148938 °
				-121.737620 °	-121.737620 °
DWR ID	DWR_ST0010_02_f_2016_21				
Comment Code					
S3 : Repair the levee slope damaged by vehicle traffic and prevent access where possible.					
Inspector Comment					
Ramp is causing depression in the levee slope.

View of the ramp encroaching into the levee.

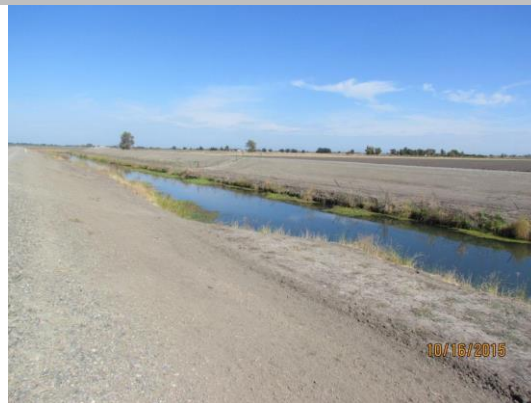
Photo 1 of 2 : SP_2019_ST0010_43_9_20190327_00003.jpg

LM Start	3.30	Rating **	A/W	Issue No.	9
LM End	4.58	Issue Type +	Ma	Location *	WS
Category	Supplemental			GPS Latitude/Longitude	
				Start	End
Item	2017 USACE Erosion Survey, DRAFT			39.153320 °	39.171031 °
				-121.734573 °	-121.727040 °
DWR ID	DWR_ST0010_02_f_2018_9				
Comment Code					
Inspector Comment					
2017 Site ID: WAC 4.3 R					
Status: Eroding					
2017 Field Notes: Site extended downstream. Significant lower bank erosion.					
Site History: 2011 - Small erosion pocket.					
LM Start	3.30	Rating **	A/W	Issue No.	9 (cont)
LM End	4.58	Issue Type +	Ma	Location *	WS

View of the erosion along the waterside toe.

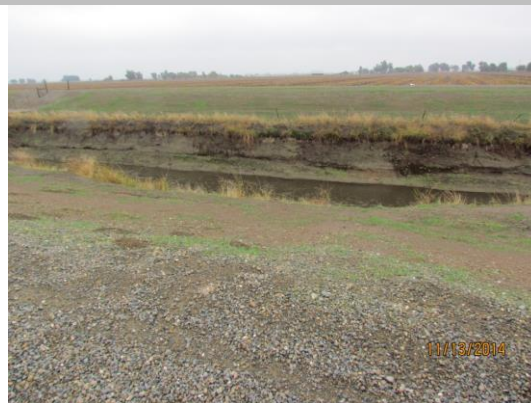
Photo 2 of 2 : SP_2019_ST0010_43_9_20190327_00004.jpg

View of the erosion along the waterside toe.
